Magnetic Flux Leakage for Tank Inspection 2F-4905

Rangga Buana

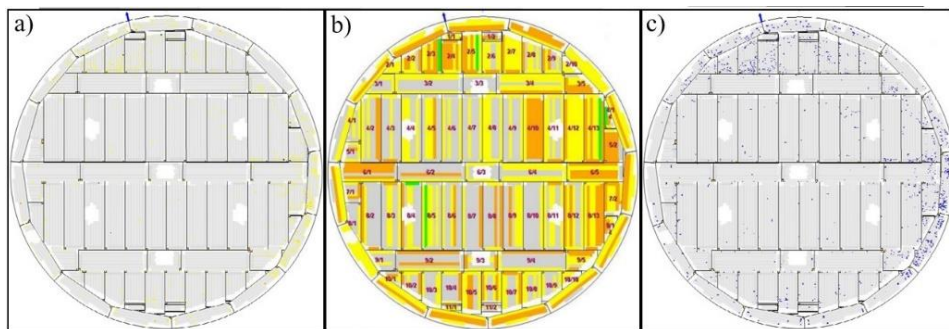
Figure 3 MFL Inspection on PX Tank 2F-4905. a) Layout data top and bottom discontinuities, b) Maximum discontinuities per track, and c) Identification results of top and bottom discontinuities

Figure 3a shows the tank floor layout resulting from the discontinuities scanning of the top and bottom of the tank floor. The total diameter of the scanned tank floor is 27,500 mm, with a total of 15 annular (ring plate) and 71 tank plates according to the numbering system agreed upon during preparation. For each length and width and thickness of the plate varies. Figure 3b shows the maximum value of discontinuities from scanning each track. Discontinuity values are distinguished based on a predetermined color scheme. Then in Figure 3c displays the results of identifying the location of discontinuities on the top or bottom tank floor which are also distinguished based on the color scheme.

From the scanning data layout, it can be seen that the discontinuities on each part of the tank floor have been seen quite a lot with varying degrees of severity. Based on the color scheme in Figure 3b, the minimum value of discontinuity severity starts from 20% marked in yellow and the maximum value is set at 100% marked in red. After obtaining the test data results that discontinuities with a severity level starting from 40% must be further verified using the UT (Ultrasonic Thickness) method to measure the thickness of the plate in order to ensure that there are no discontinuities that do not comply with the acceptance criteria (Pearson et al., 2016). The data is presented in Table 1.

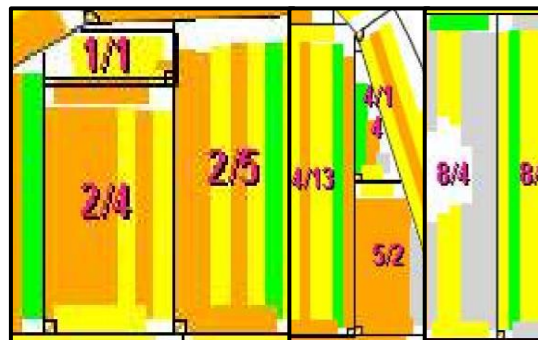
Of all the tank sections tested, defects were found at a severity level of 40% - 49% marked with a green color scheme which is the most severe discontinuity as shown in Figure 4.

Based on the data in Figure 4, it can be seen that there are 6 discontinuities found with values above 40%. Therefore, these 6 discontinuities

must be further verified so that the UT verification test results are obtained as shown in Table 1. The measured discontinuity area and thickness are still <100 mm and <10 mm. This is still said to be safe because the severity of the discontinuities found in the tank is still low and PT MCCI still does not want to patch the tank.

Figure 4 Defects with the highest severity found during scanning

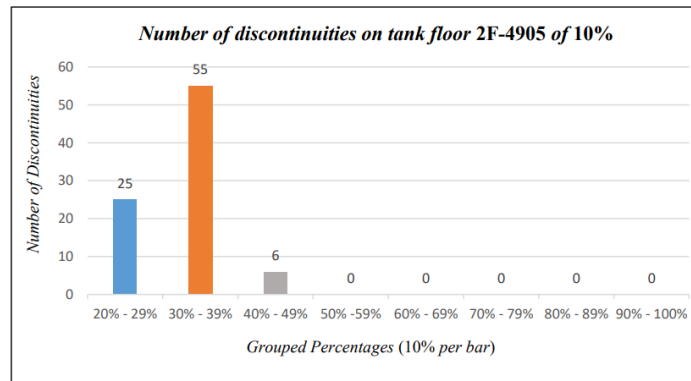
Referring to the experimental data, statistical data was also obtained which displayed a diagram of the number of discontinuities in Tank 2F-4905 with a total of 86 and divided by the percentage group of the damage level. So from there, we get a discontinuity percentage diagram that has been calculated based on the number and percentage group of

the damage level. It can be seen that the highest severity of damage is in the range of 40% - 49% and the average severity of damage is in the range of 30% - 39% which states that the tank is still in a safe condition. This is an agreement from PT MCCI in this test. For more details can be seen in Figure 5 and Figure 6.

Figure 5 Number of Discontinuities in Tank 2F-4905

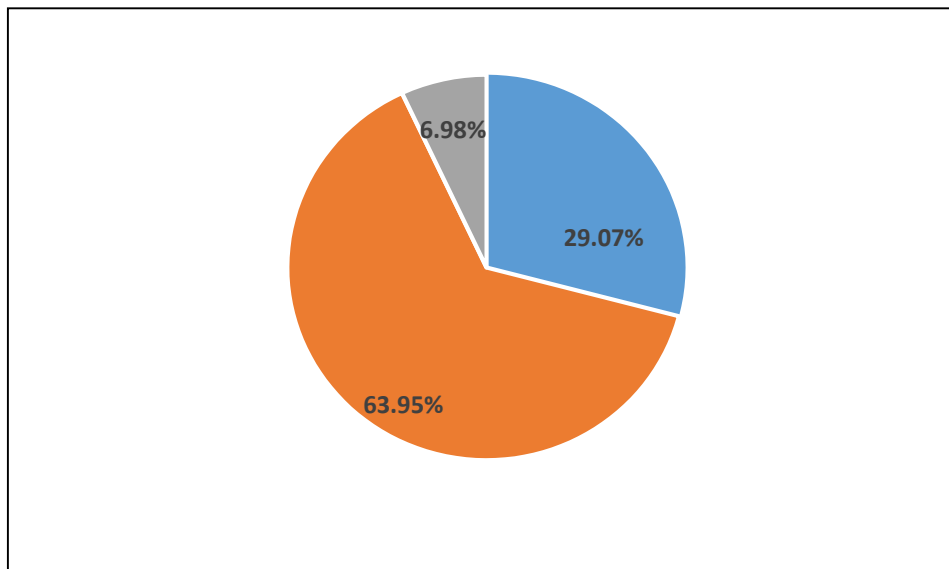
Figure 6 Percentage of discontinuity in 2F-4905 tank

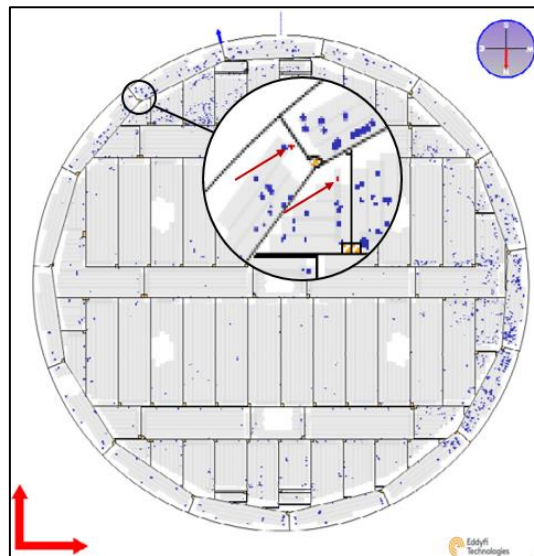
Based on further specifications in the experimental data, it is also shown that the test is more focused on the bottom plate. This is because the bottom of the tank which will later hold more loads - heavy loads so that testing is more tightened (Wu et al., 2021). It is proven by the test results obtained that more discontinuities are detected at the bottom plate. As seen in Figure 7. It can be seen that there are only 2 top discontinuities from all parts of the tank. This indicates that the heavy load accommodated also affects the discontinuities to be more. However, the

water collected by the tank does not have such strong corrosive elements as living organisms so there are not many discontinuities that appear at the top of the tank. Discontinuities that arise at the top and bottom plate are very dangerous because they can cause the tank to be unable to be used further because the discontinuity holes can penetrate the plate and occur suddenly. So that routine testing is needed so that the condition of the tank can be controlled and does not cause danger to the surrounding (Kang et al., 2021).

Figure 7 Top Discontinuities
