Metal Failure Analysis and Maintenance Planning on Gasoline Storage Tank Pipe PT Pertamina Refinery Unit VI

Asfitrah Alamsyah

Department of Metallurgical Engineering, Faculty of Mineral Technology,
UPN "Veteran" Yogyakarta, Jl. Padjadjaran Condongcatur Yogyakarta 55283
E-mail : aasfitrah@gmail.com

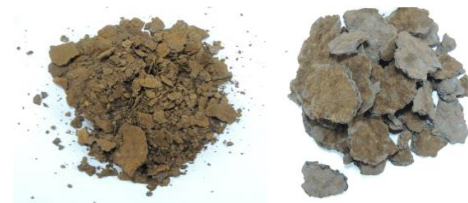
different sections at 6 o'clock and 12-4 o'clock in the gasoline storage tank pipeline. In this visual inspection observation, several things are observed on the deposited sample including characteristics, colour, or other things related to the deposit sample which will be used as data so that later the root cause of corrosion that occurs in the gasoline storage tank pipe can be found. From the results of visual inspection observations, the gasoline storage tank pipe deposit sample shown in Figure 1 is obtained.

Figure 1 Gasoline Storage Tank Pipe Deposit Sample (Source: Sustainability_Report_Refinery_Unit_VI, n.d.)

By visual observation, the two samples have different characteristics, which look like small flakes and chips (Mobley, 1999). The difference in sample characteristics is influenced by the cause of corrosion that occurs on the inside of the gasoline storage tank pipe. The colour of the deposit sample was dominated by brown and some dark grey flakes were found at the bottom of the pipe surface (Ahmad et al., 2010). One of the deposit samples had a different thickness, indicating that the formation of this deposit could have been formed over a long period of time.

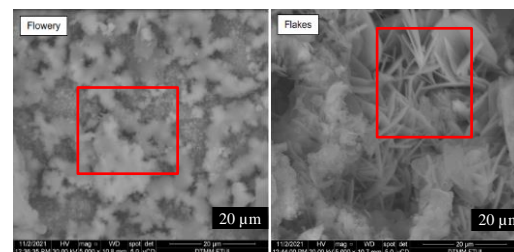
Scanning electron microscope (SEM) testing was carried out on two samples, namely gasoline storage tank A and gasoline storage tank D. The results of SEM observations showed flowery and flakes structures. These structures provide a non-protective layer when on the surface of carbon steel (Zhou et al., 2020). The results of SEM testing on gasoline storage tank A are shown in **Figure 2**.

Figure 2 SEM Microscopy Results of Gasoline Storage Tank Deposit A (Source: Sustainability_Report_Refinery_Unit_VI, n.d.)

SEM microphotographs showing irregular flowery structures may indicate a

type of surface defect known as a flowery structure. These defects are characterized by small circular indentations or pits on the steel surface arranged in a flower-like pattern. The cause of flowery patterns is thought to be the result of a combination of factors, including the chemical composition of the steel, the manufacturing process, and the presence of certain types of contaminants.

The flowery patterns can negatively impact the performance and integrity of steel by reducing its strength and corrosion resistance (Masuyama, 2007). These patterns can also affect the surface finish of the material and make it more susceptible to wear and fatigue. There is a close relationship between the flake pattern in the SEM examination results and the degree of damage caused by steel corrosion (Othman et al., n.d.). The flakes pattern shows that there has been a rusting process on the surface of the gasoline storage tank pipe. The flake pattern seen on the surface of the corroded steel can provide information about the level. The pattern of flakes seen on the surface of the steel that has been corroded can be a pattern of flakes that are tighter or more tenuous. A tighter flake pattern indicates that the level of damage to the steel is more severe. On the other hand, a tighter flake pattern indicates that there is less damage to the steel (Society of Mechanical Engineers, n.d.).

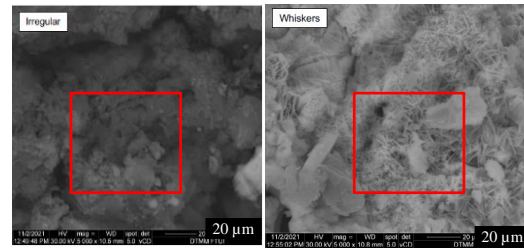
The results of SEM testing on gasoline storage tank D show the presence of irregular structures and whiskers shown in **Figure 3**. These two structures indicate the presence of corrosion that occurs in steel.

Figure 3 SEM Microscopy Results of Gasoline Storage Tank Deposit D. (Source : Sustainability_Report_Refinery_Unit_VI, n.d.)

SEM microphotography results show the presence of irregular structures that can indicate defects or imperfections found on the surface of the sample on the gasoline storage tank pipe. Some common types of defects that may be seen in irregular structures include inclusions, cracks, voids, or other surface imperfections. These defects may result from manufacturing processes, handling, or exposure to environmental conditions. In addition, irregular structures may also exhibit other microstructural features such as grain boundaries and phases that can affect the mechanical properties of the material on the gasoline storage tank pipe surface. The microphotographic results of irregular whiskers may indicate the presence of whiskers on the surface of gasoline storage tank sample D. The size, shape, and distribution of whiskers can provide information about the conditions that led to their formation and can help identify the root cause of whiskers growth that will affect the durability and wear of gasoline storage tank D.

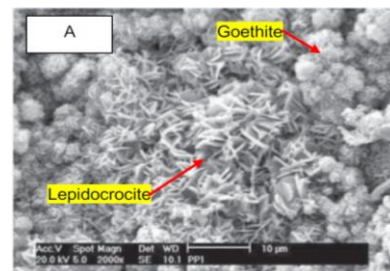
These lepidocrocite can further undergo oxidation to form other iron oxides such as goethite (α -FeOOH) which can then be further transformed into hematite due to dehydration of $Fe_2O_3 \cdot H_2O$ on the carbon surface of steel. hematite (Fe_2O_3) is a corrosion product of carbon steel that we have known visually. The formation of an oxide layer on the steel surface contributes to the depletion of oxygen below the layer which then results in the formation of magnetite (Fe_3O_4) as a product. then results in the formation of magnetite (Fe_3O_4) as a product. This compound was also identified in the results of XRD analysis. The results of the SEM micrography of epidocrocite can be seen in **Figure 4**.

Figure 4 SEM micrographic results of epidocrocite. (Sustainability_Report_Refinery_Unit_VI, n.d.)

These corrosion products form a layer on the surface of the carbon steel, which then acts as a deposit. Deposits on the internal surface of the pipe are the main cause of general corrosion and pitting corrosion, identified as under-deposit corrosion. The corrosion rate in the area

under the deposit is higher than in other areas not covered (Nyoman Adnyana, 2017). It is also known as micro-galvanic because the area covered by the deposit is more anodic than others due to oxygen depletion beneath the deposit layer.
