## THE RECLAMATION TECHNICAL PLAN ON ANDESIT MINING IN DADIREJO VILLAGE, BAGELEN DISTRICT, PURWOREJO REGENCY, CENTRAL JAVA PROVINCE

Boy Arif Raja Ihutan Siregar<sup>1)</sup>; Dian Hudawan Santoso<sup>2)</sup>; Muammar  
Gomareuzzaman<sup>3)</sup>

Environmental Engineering Study Program, Faculty of Mineral Technology,  
Universitas Pembangunan Nasional Veteran Yogyakarta

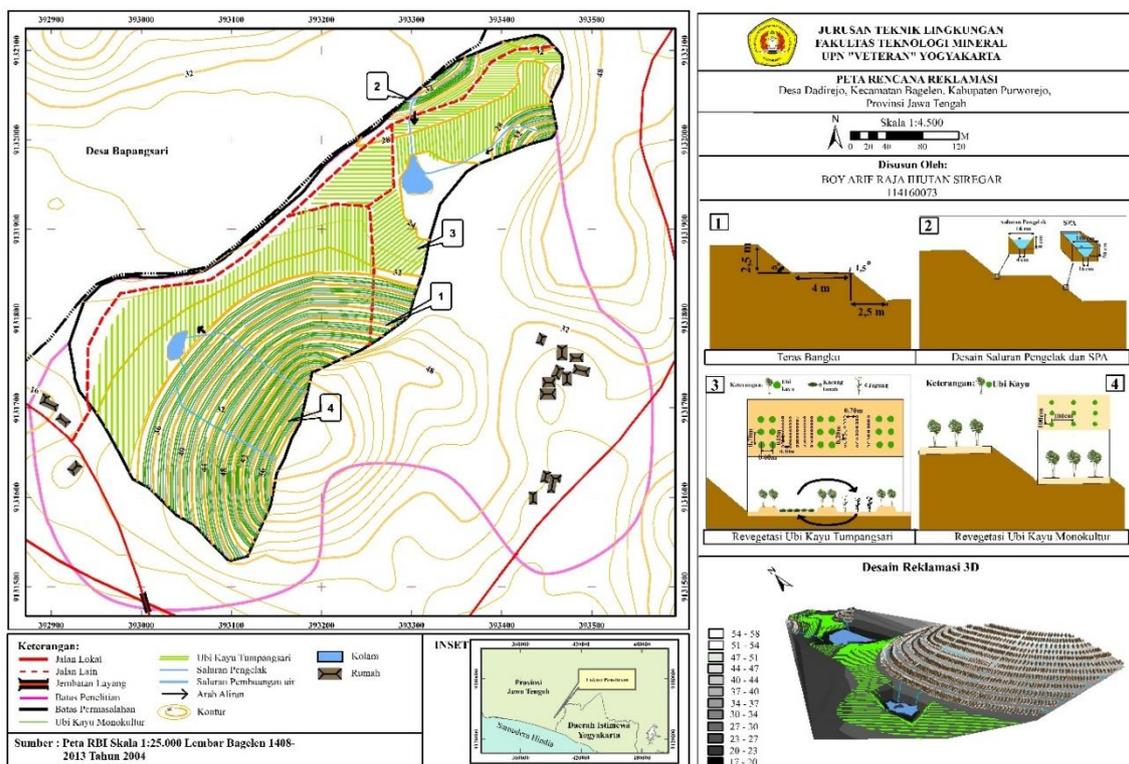
Figure 1. Mining Area Management Direction Map

The planned land arrangement in the mining area is a bench terrace with a height and width of 2.5 x 4 m and a single tier slope angle of 40°. The field if the level is uneven, a backslope is made with evasion. The results of the land arrangement are obtained by land in the form of plains, terraces, angles of 1.5° with the aim of reducing erosion due to runoff and the water can flow towards the drainage channel (SPA) to the holding pond to be made and make slopes. safer from the threat of soil and or rock mass movements which can be seen in the cross-sectional sketch of Figure 1.

After arranging the stairs with a bench feel, after that make a model for the drainage channel and avoidance. The construction of sewerage channels (SPA) and bypass channels do not escape the land management system. The availability of SPA and avoidance channels serve to minimize the impact of erosion, surface flow can flow calmly to the place of the reservoir so as not to damage the soil surface or plants (Fridiyandra, 2015). The runoff that flows from each step towards the avoidance channel in the edge of the step is made in the direction of the contour due to the backslope. Furthermore, the runoff from the drain channel to the SPA is made from gravel material of mineral waste. Because the mining area at the research site is quite large, the distance of each SPA to the other is 200 m. The temporary outlet of the SPA is the pool. The SPA grooves lead to the lower spot which can be seen in Figure 1.

Cassava plants are interspersed with peanuts and corn that are planted alternately to reduce weed growth and pest and disease attacks (Sundari, 2010). The intercropping pattern is done by arranging the planting distance of cassava in such a way that the space between the rows of cassava can be planted with peanuts and corn. Cassava was planted in double rows with a planting distance (0.6 mx 0.7 m) x 2.6 m. The planting distance of 0.6 mx 0.6 m is the distance of planting cassava in double rows, while 2.6 m is the distance between double rows of cassava. The distance between double rows of cassava can be planted with peanut plants with a distance of 0.4 mx 1.5 m or corn with 0.7 mx 0.2 m which can be seen in Figure 1.

The technique for cultivating cassava in monoculture is the same as intercropping, only the spacing is different. The planting distance of cassava in monoculture that was chosen was rather tenuous, with a distance of 1 mx 1 m which can be seen in Figure 1. Cassava plants require a soil depth of at least 30 cm. Therefore, to reach 30 cm, successive accumulation of topsoil is carried out from the bottom layer, namely 20 cm thick topsoil, and 10 cm thick fertilizer is applied.
