THE RECLAMATION TECHNICAL PLAN ON ANDESIT MINING IN DADIREJO VILLAGE, BAGELEN DISTRICT, PURWOREJO REGENCY, CENTRAL JAVA PROVINCE

Abstract

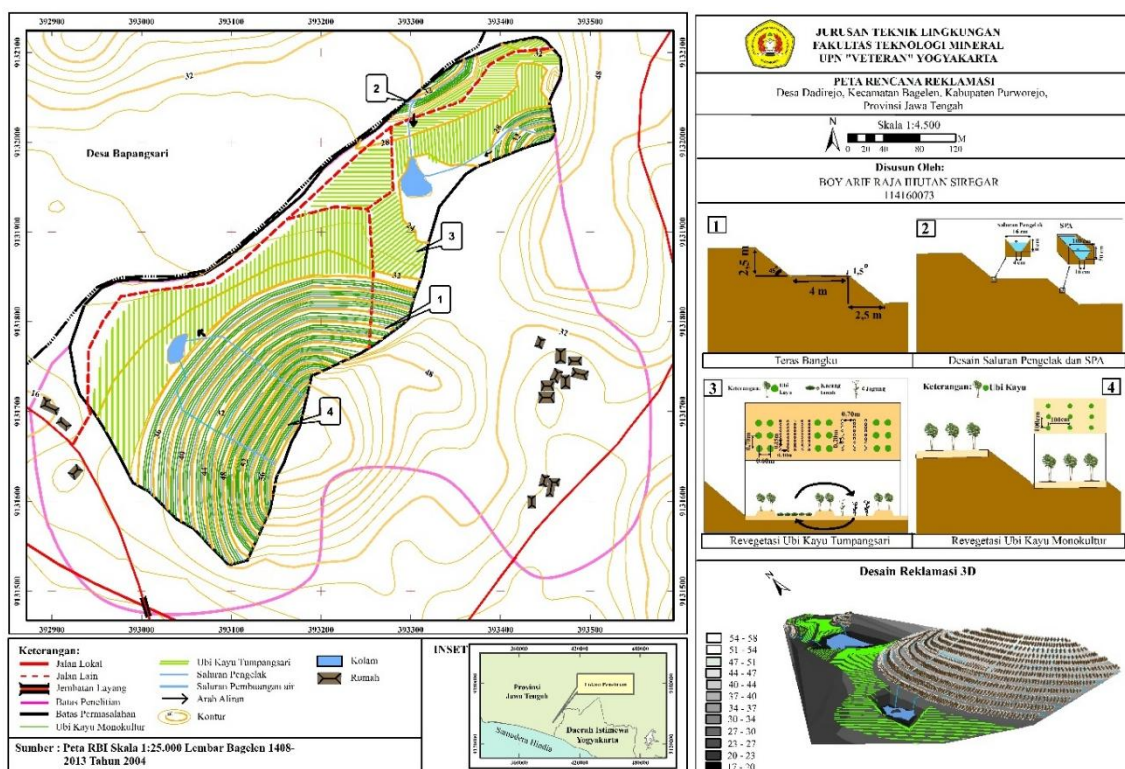
Figure 1. Mining Area Management Direction Map

determine environmental damage As a whole, it can be seen in Table 3, the results show that the mining location in Dadirejo Village is classified as class III with a value of 16. Based on Table 3, this value is classified as severe physical environmental damage. This can happen because at the beginning of mining activities there was no planning and attention to the environment, so mining activities were carried out arbitrarily.

Num	Parameter	Score	Criteria
1	Base Relief Excavation	3	Damaged
2	Boundry Slope of Excavation	3	Damaged
3	Wall Height of Excavation	3	Damaged
4	Road Condition	2	Moderate
5	Vegetation Cover	2	Moderate
6	Depth of Excavation	1	Well
7	Edge Boundaries	1	Well
	Sum	16	Damaged

The land to be reclaimed is located in Dadirejo Village, Bagelen District, Purworejo Regency, Central Java Province. The research area is an andesite mining area which has a height of about 20 – 68 meters above sea level. The area of land to be reclaimed in the research area is 111,000 m² . Mining land after surveys and measurements based on several parameters is categorized into moderate and severe physical environmental damage.

The planned land arrangement in the mining area is a bench terrace with a height and width of 2.5 x 4 m and a single tier slope angle of 40°. The field if the level is uneven, a backslope is made with evasion. The results of the land arrangement are obtained by land in the form of plains, terraces, angles of 1.5° with the aim of reducing erosion due to runoff and the water can flow towards the drainage channel (SPA) to the holding pond to be made and make slopes. safer from the threat of soil and or rock mass movements which can be seen in the cross-sectional sketch of Figure 1.

After arranging the stairs with a bench feel, after that make a model for the drainage channel and avoidance. The construction of sewerage channels (SPA) and bypass channels do not escape the land management system. The availability of SPA and avoidance channels serve to minimize the impact of erosion, surface flow can flow calmly to the place of the reservoir so as not to damage the soil surface or plants (Fridiyandra, 2015). The runoff that flows from each step towards the avoidance channel in the edge of the step is made in the direction of the contour due to the backslope. Furthermore, the runoff from the drain channel to the SPA is made from gravel material of mineral waste. Because the mining area at the research site is quite large, the distance of each SPA to the other is 200 m. The temporary outlet of the SPA is the pool. The SPA grooves lead to the lower spot which can be seen in Figure 1.

Cassava plants are interspersed with peanuts and corn that are planted alternately to reduce weed growth and pest and disease attacks (Sundari, 2010). The intercropping pattern is done by arranging the planting distance of cassava in such a way that the space between the rows of cassava can be planted with peanuts and corn. Cassava was planted in double rows with a planting distance (0.6 m x 0.7 m) x 2.6 m. The planting distance of 0.6 m x 0.6 m is the distance of planting cassava in double rows, while 2.6 m is the distance between double rows of cassava. The distance between double rows of cassava can be planted with peanut plants with a distance of 0.4 m x 1.5 m or corn with 0.7 m x 0.2 m which can be seen in Figure 1.

The technique for cultivating cassava in monoculture is the same as intercropping, only the spacing is different. The planting distance of cassava in monoculture that was chosen was rather tenuous, with a distance of 1 m x 1 m which can be seen in Figure 1. Cassava plants require a soil depth of at least 30 cm. Therefore, to reach 30 cm, successive accumulation of topsoil is carried out from the bottom layer, namely 20 cm thick topsoil, and 10 cm thick fertilizer is applied.
