Experimental Study on the Corrosion Rate Influence Caused by Seawater on Aircraft Structures

Marga Dharma Prayoga^{1*}, Heru Susanto¹, dan Muhammad Luqman Bukhori¹

Abstract

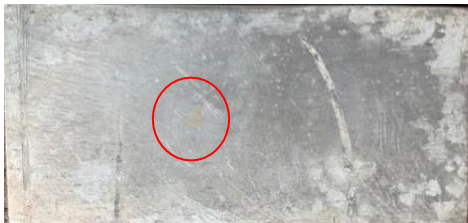
Figure 1.
Results of immersion and drying of seawater

In Figure 1, the longest exposure duration is 168 hours, and visually, the surface of the Aluminium appears to have corrosion, as it shows a brownish tint. However, at this point, it cannot be confirmed whether it is indeed corrosion or not. Therefore, a microscopic examination was conducted to closely observe the surface of the Aluminium and determine whether corrosion has occurred or not.

Figure 1 illustrates the results of immersion and exposure at seawater and rainwater locations, where the immersion process was conducted at different time intervals, specifically 0, 72, 168, and 336 hours.

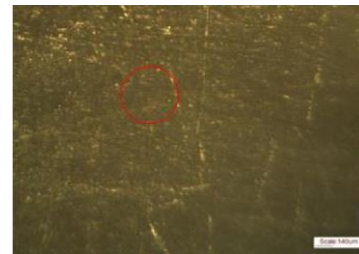
Figure 3

Results of micro-aluminum photographs with seawater media

From the microscopic examination in Figure 3, it was initially indicated that there might be corrosion at the red circle; however, after conducting the microscopic analysis, it was confirmed that there is no corrosion at that point. Therefore, the weight reduction observed in the aluminum during the weight loss test is a result of abrasion on the surface of the aluminum. This is because Aluminium 2024-T3 contains certain compounds, one of which includes iron or other metals, leading to the occurrence of corrosion in the aluminum mixture. This is further supported by the very minimal corrosion rate observed in this research.
