***EVALUATION OF THE SUCCESS OF FOREST RECLAMATION ON COAL
MINING LAND IN THE IUP AIR LAYA MINING
PT. BUKIT ASAM TBK, KAB. MUARA ENIM, SOUTH SUMATRA***

Jihan Putri Maharani dan M. Kundarto¹⁾

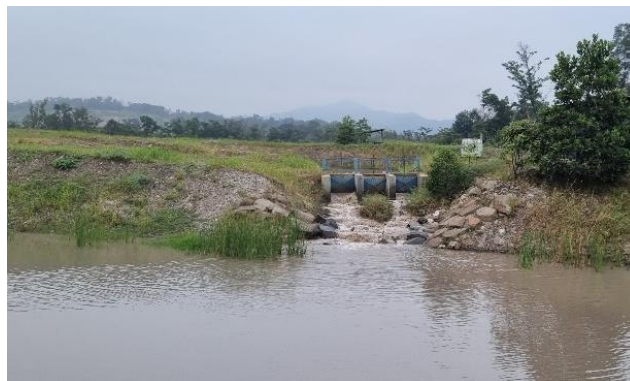
Figure 4. Illustration of check dam and riprap (rock)

The next land conservation structure found in the research location is a check dam. A retaining embankment or check dam is a small dam with a simple construction (embankment of soil or rocks), made in a ravine or small river channel. The check dam functions to hold/control sediment and surface water flow from the catchment area in the upstream section. An illustration of the check dam at PT. Bukit Asam Tbk is presented in Figure 4 below.

In addition, erosion is prevented by installing rocks on check dams and drainage channels in the form of riprap (Figure 5). Riprap is a composition of rock blocks placed in drainage channels and check dams. This conservation structure functions as a protective layer to reduce the depth of local erosion and to protect

the base soil downstream of the dam energy absorber. Riprap can be placed along the outer edge of the river bend, to eliminate the force of water against the river bank (Figure 5), and also near bridges along the embankment and adjacent to supports in water channels (Figure 4).
